REHABILITATION OF SMALL AND MEDIUM SPAN CONCRETE BRIDGES

- SOME EXAMPLES -

Válter Lúcio

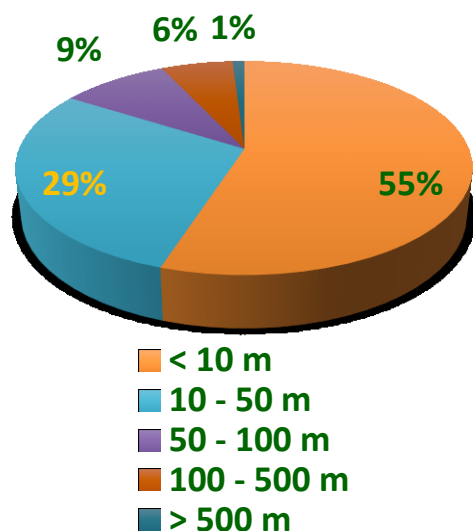
Percentage of bridges per span length
in Portugal

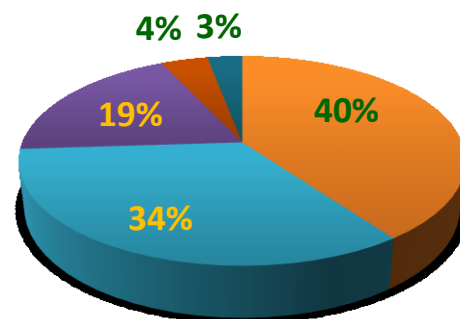
Percentage of bridges per type of structure
in Portugal

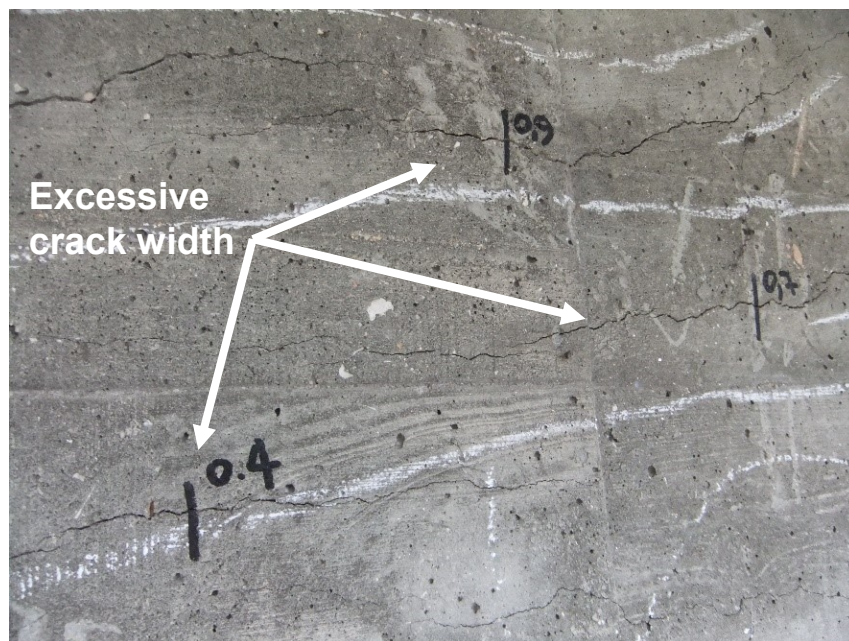
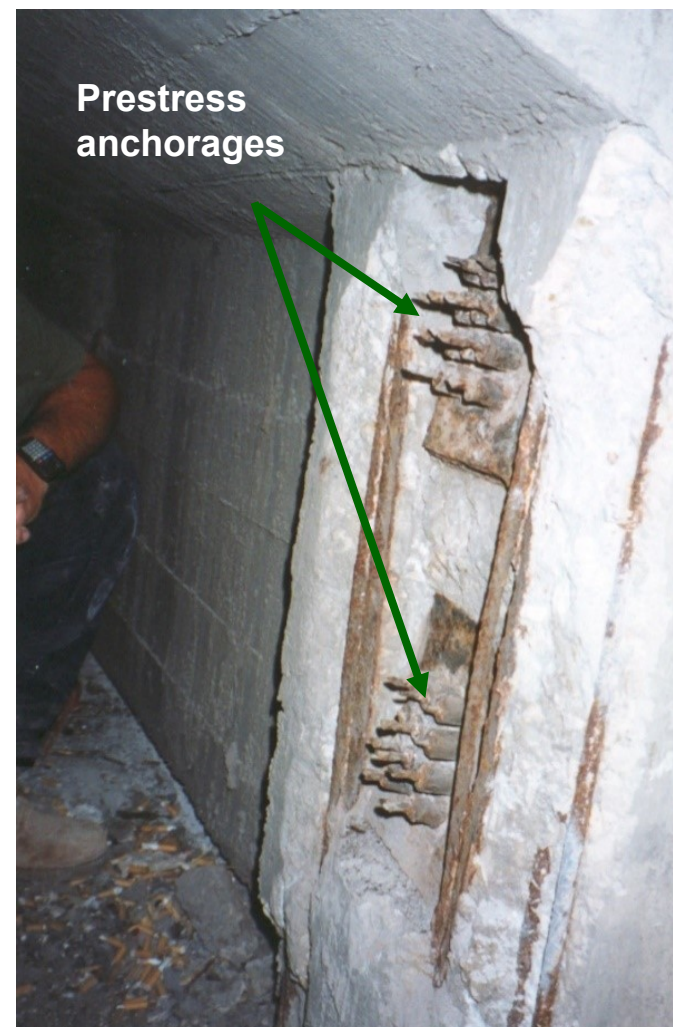
Example of construction error.

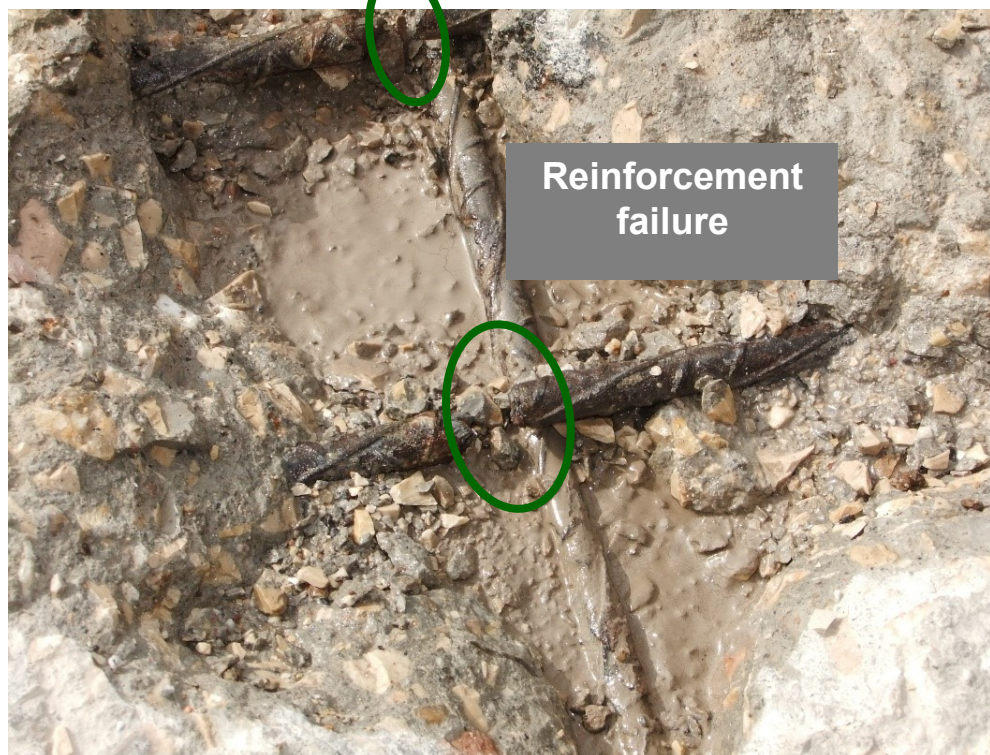
**Example of
reinforcement failure
due to design error.**

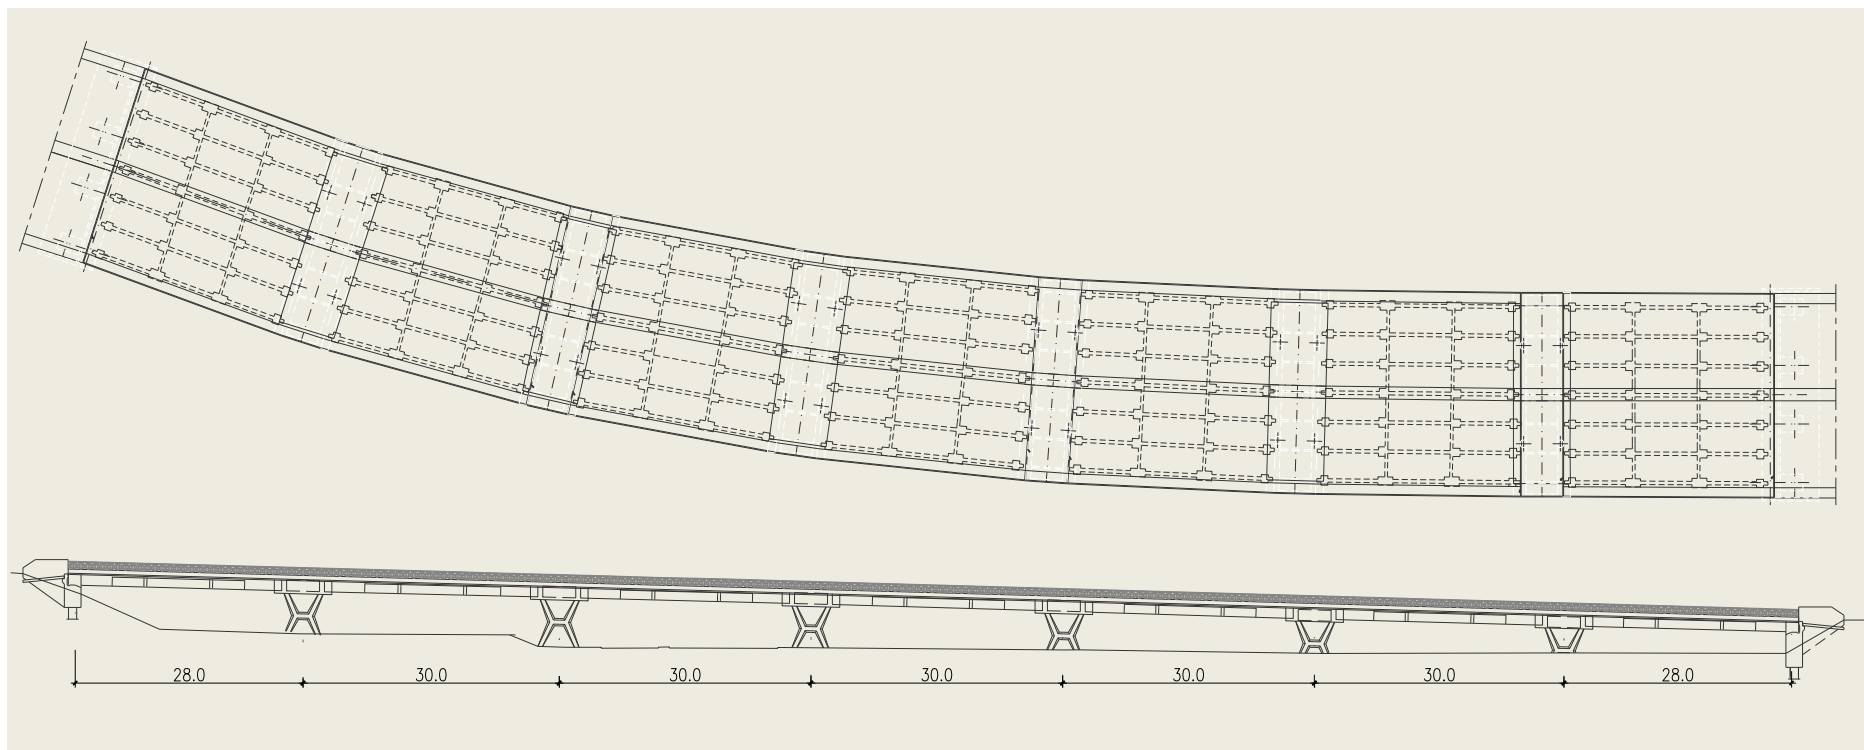
Viaduct in Lisbon.

The deck is 25 m wide.

It has 7 spans, with longitudinal prestressed concrete beams 25m long.

The deck is supported by transversal frames with columns with X shape and a box girder.

There are transversal beams over the supports and at 1/3 of the span.

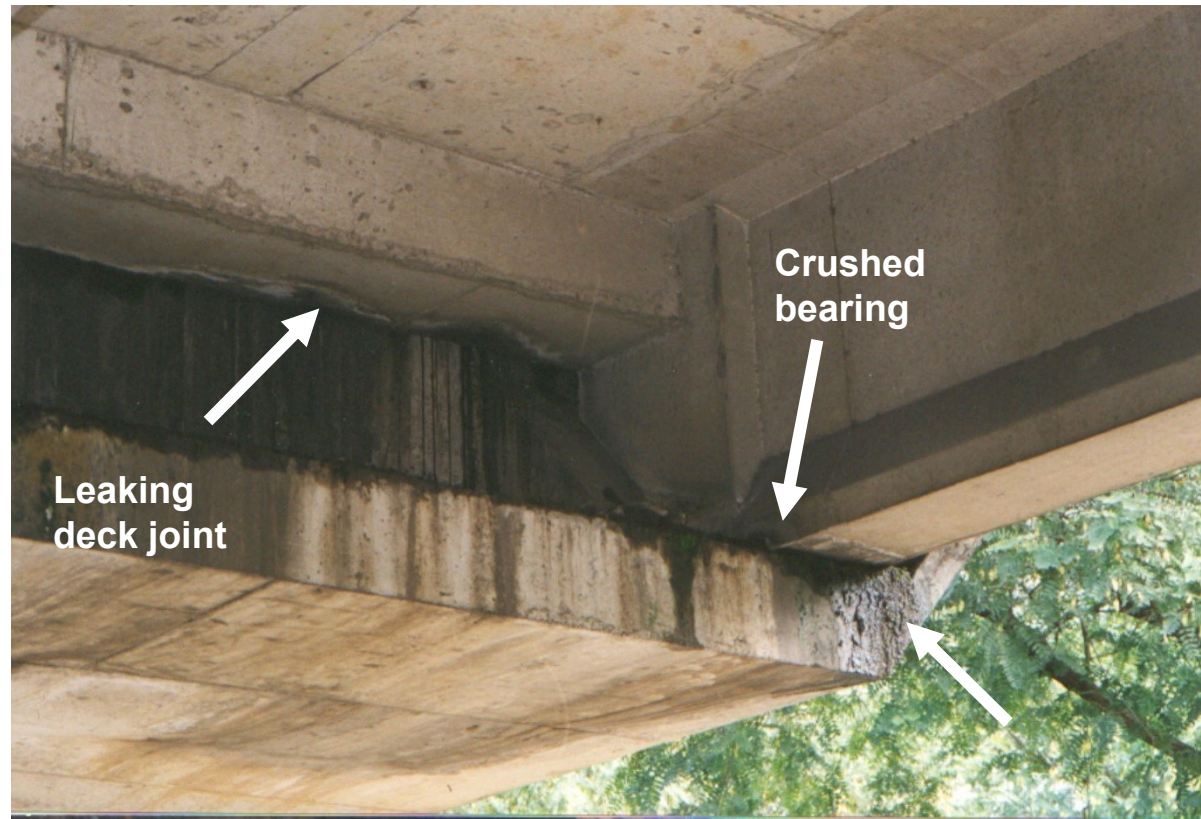
- Deterioration of the deck joints and degradation of the surrounding structure;
- Neoprene bearings crushed;

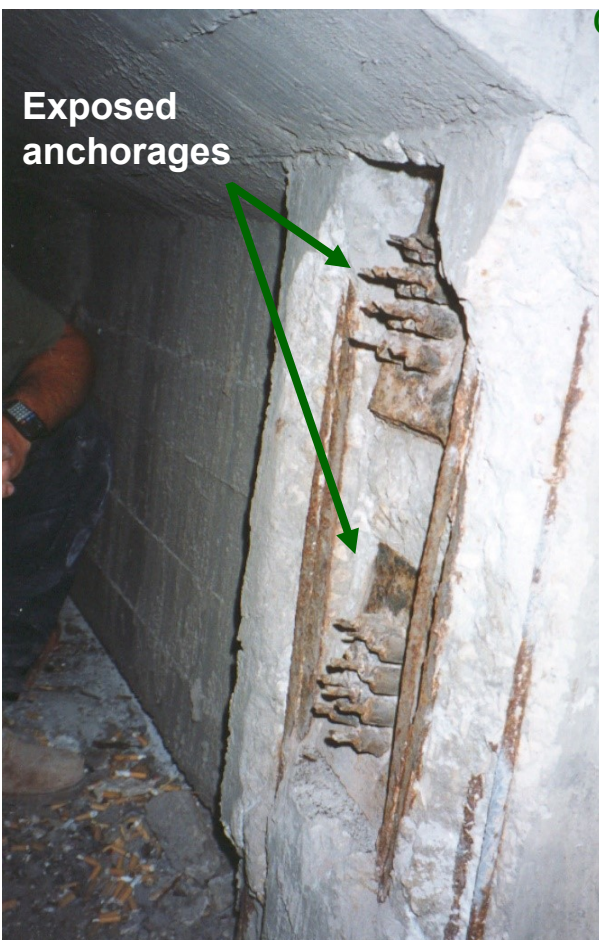
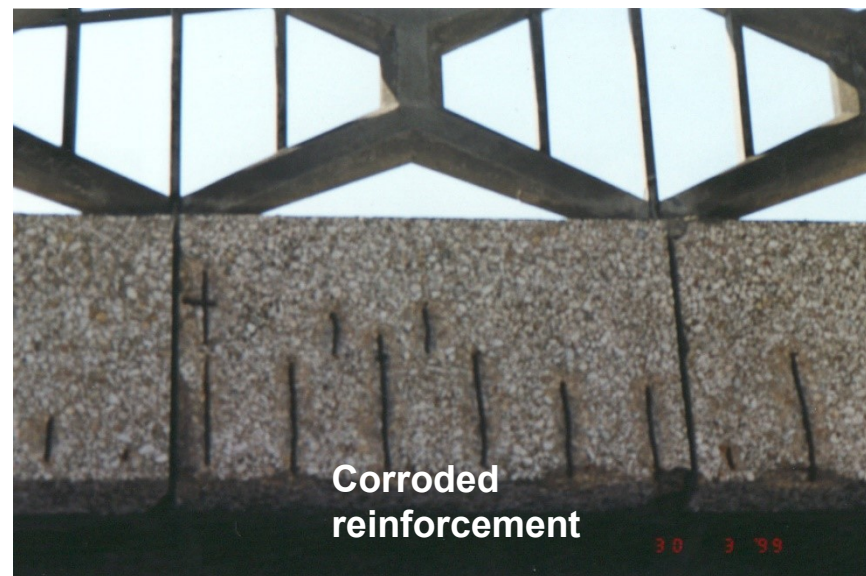
- Columns, transversal box girders, longitudinal beams and facies with reinforcement corrosion and concrete delamination;

- Cleaning of the corroded reinforcement and concrete reshape with structural grout;
- Injection of some cracks with epoxy resin;
- Painting the concrete surface with acrylic paint in order to control the concrete carbonation process;
- Replacement of the
 - neoprene bearings,
 - the deck joints,
 - the bituminous surfacing,
 - the drainage system,
 - the fascia,
 - and the parapets.

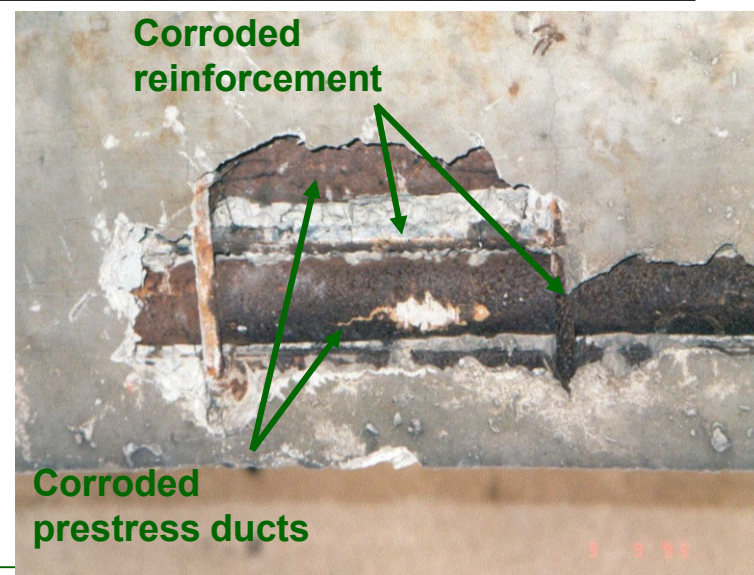
- Exposed prestress anchorages and ducts, with corrosion.

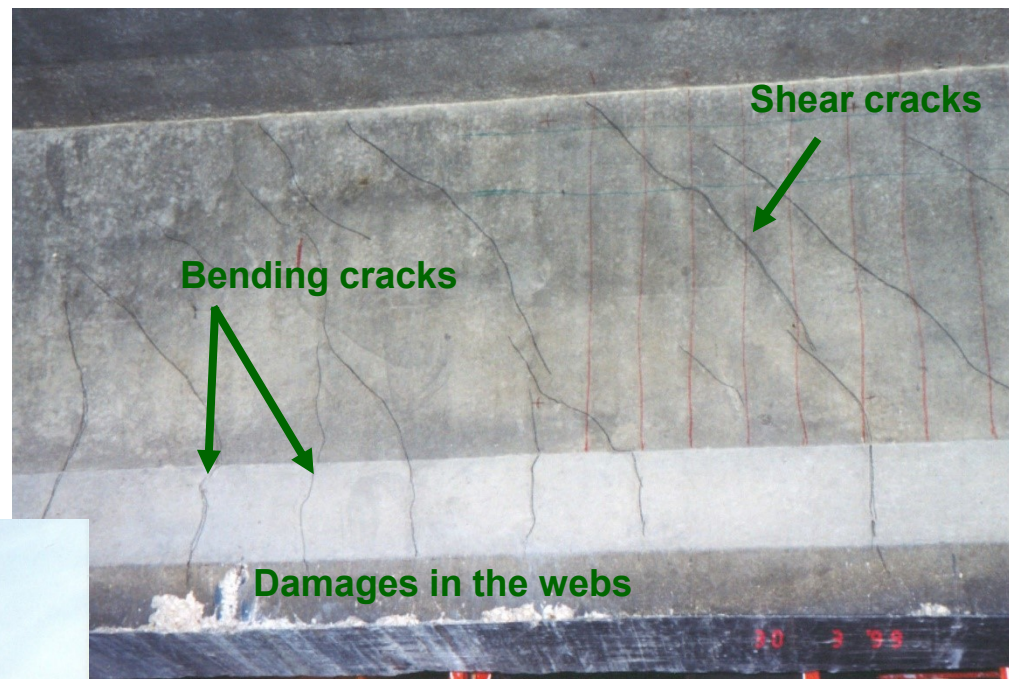
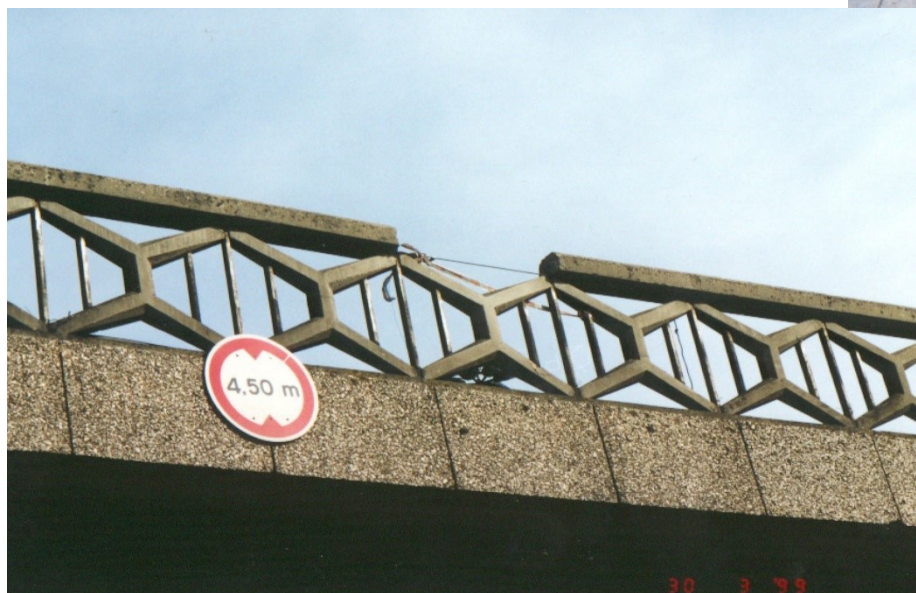
- Excessive deformation of the main beams, also with excessive cracking due to shear and bending;
- Damages due to accidental loading in the bottom flange of the main beams and in the parapets.

Objectives for the main beams:

- Improve the bending and shear resistance;
- Reduce the deformation and close the bending and shear cracks.

- External prestress with inclined bars, anchored in concrete blocks;
- Concrete overlay in the webs near the supports.

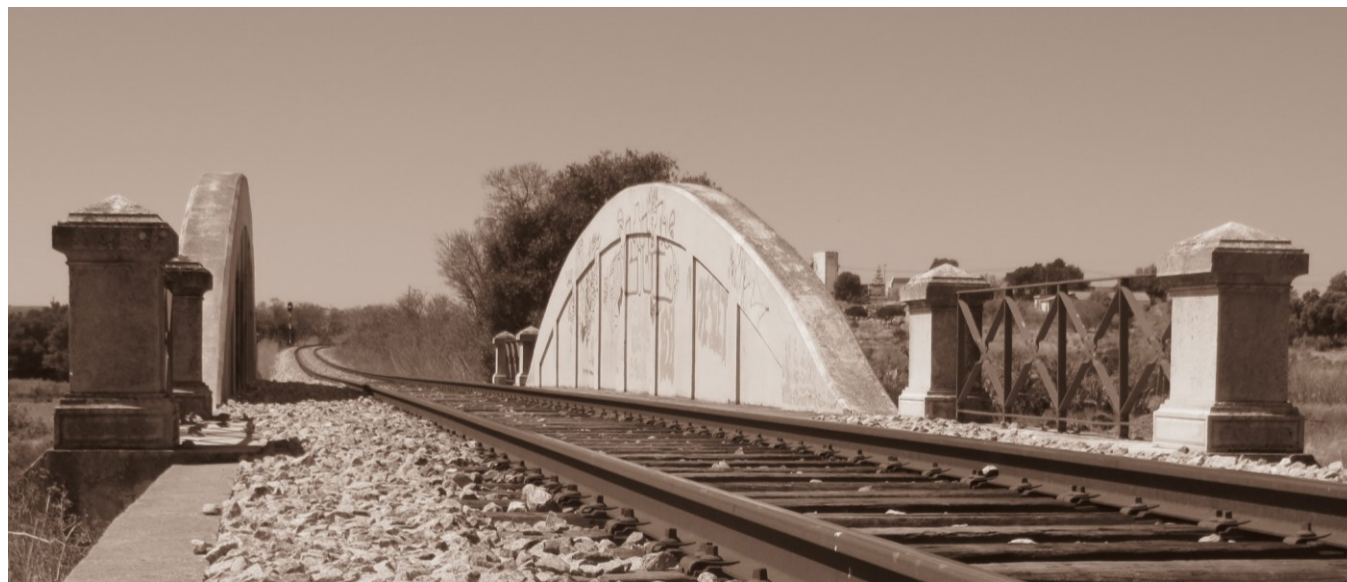
The Farelo River Bridge is a tie-arch bridge with a span of 24.90 m.

The bridge includes two arches and a lower deck that holds the horizontal tie forces of the arch. There are vertical ties that transfer the deck loads to the top chord. Concrete walls close the areas between the ties, the deck and the top chord.

The deck has transversal beams, held by the vertical ties, two longitudinal main beams, in the arches planes, and two secondary longitudinal beams.

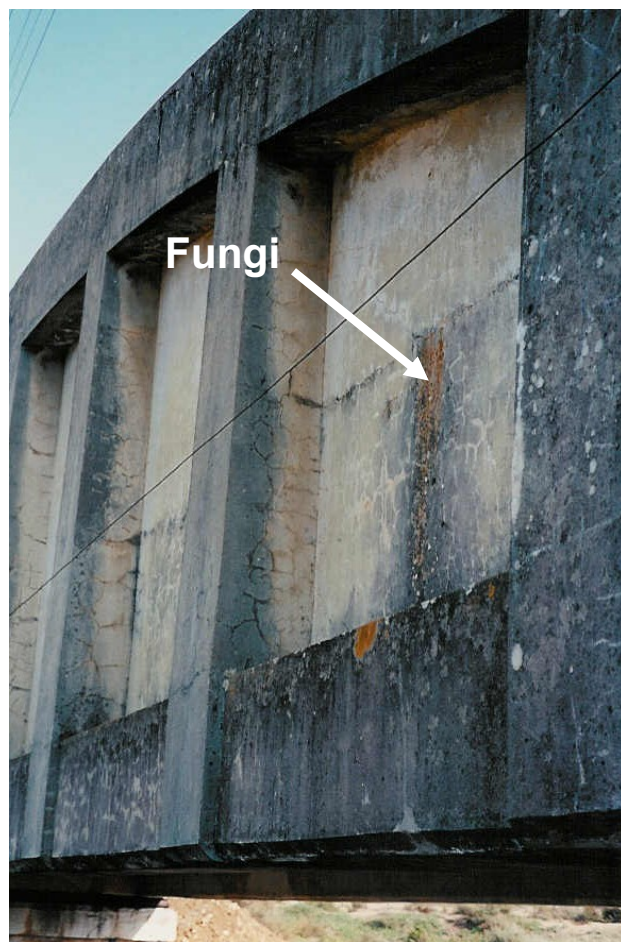
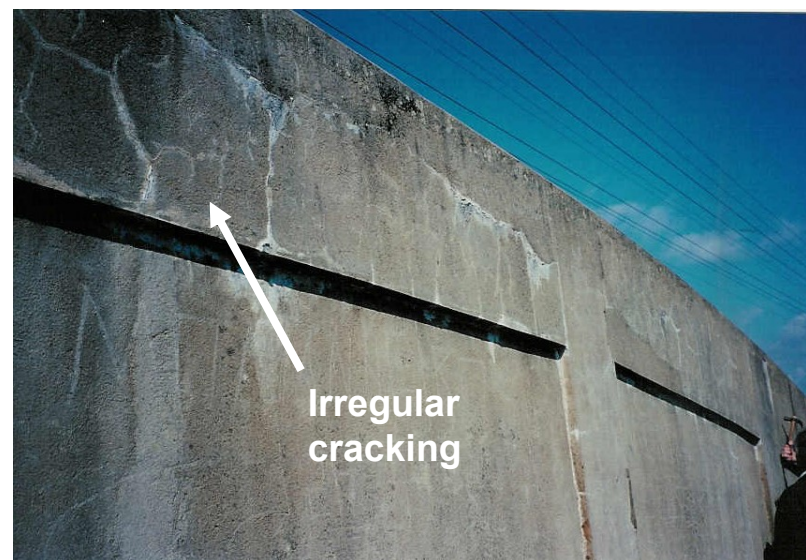
All the concrete surface was rendered with a cementitious grout. This render had an irregular cracking pattern, due to differential shrinkage, and in many places it was loose from the concrete base. On the North side, not exposed to sun beams, there were fungi that kept the humidity on the surface.

- replacing the loose render by shrinkage controlled grout;
- repairing the areas of concrete with reinforcement corrosion;
- improving the drainage system and the waterproofing of the deck;
- cleaning the bridge bearings;
- painting all the surface with acrylic paint to protect the concrete against carbonation and chlorites.

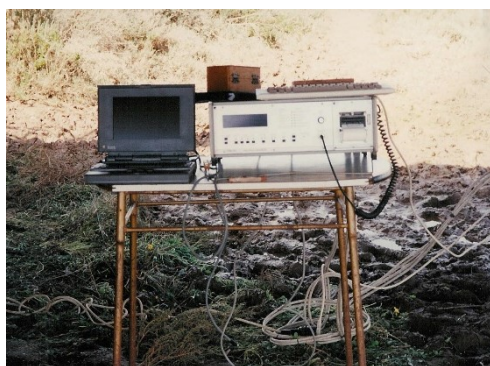
Monotonic and dynamic loading tests were done, with measurements of displacements in several points of the bridge deck.

**Data logger and
computer for the
loading tests**

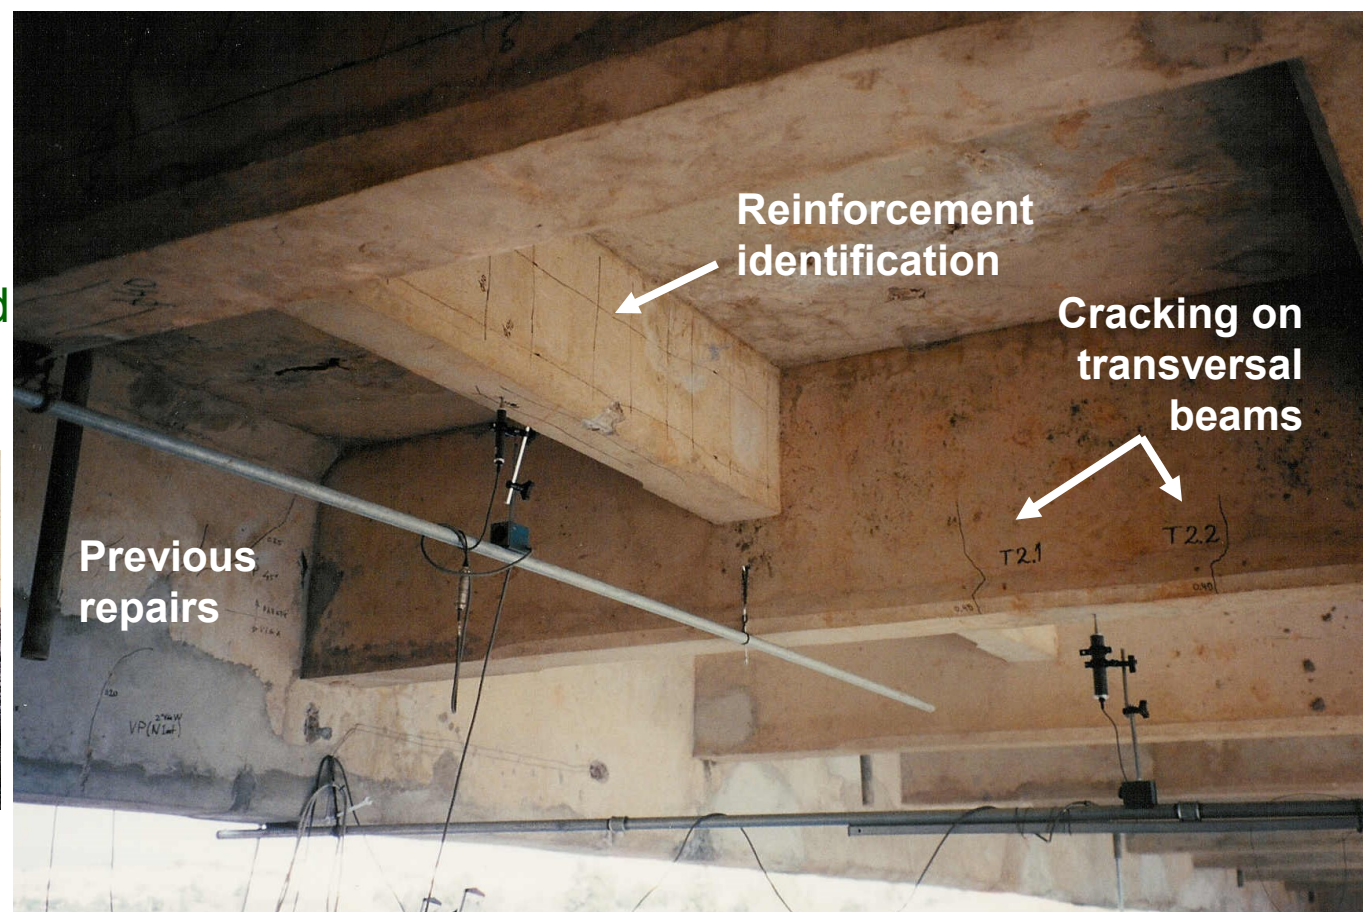
View of the displacement transducers below the deck

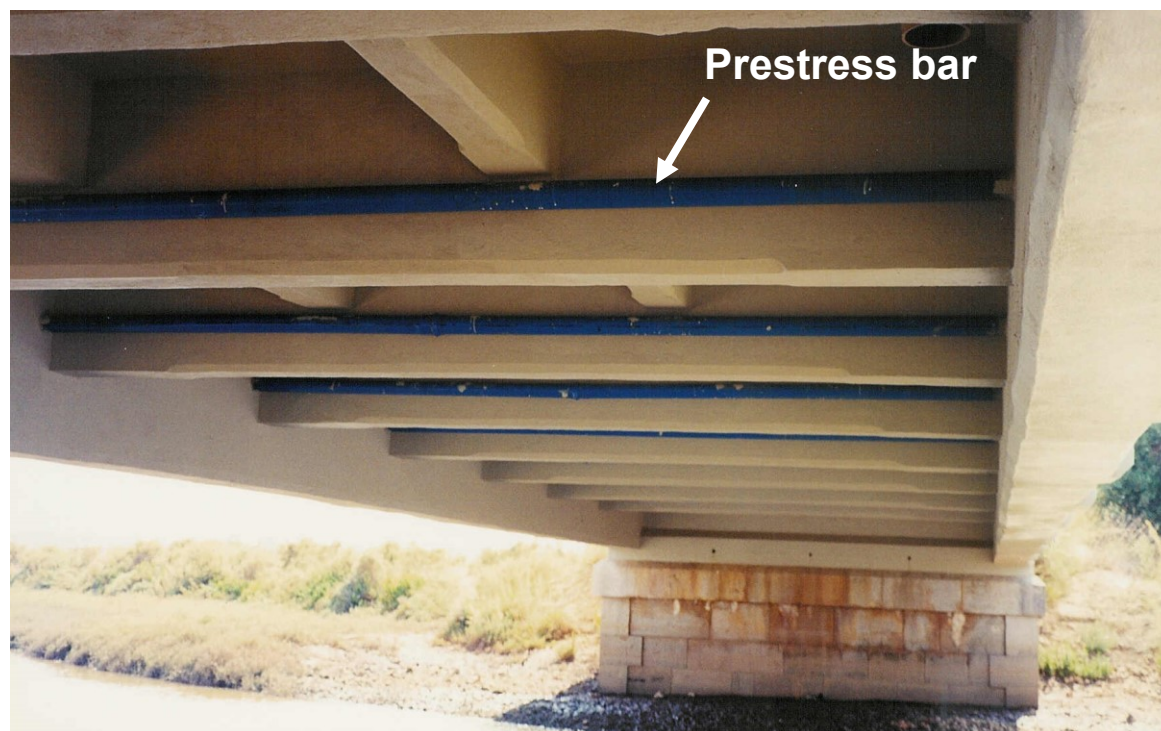
The numerical analysis and the tests revealed that the transversal beams were not verifying safety for bending and crack widths.

The transversal beams were strengthened with external prestress for bending resistance and crack width control.

Each transversal beam was prestressed with two 26.5 mm diameter high strength steel bars, inside high density polyethylene ducts injected with grout.
